Failure Mechanisms and Material Degradations at High Temperatures in Ammonia Plants

Dr. Jürgen Korkhaus
BASF Aktiengesellschaft

Dr. Rainer Feser
BASF Aktiengesellschaft

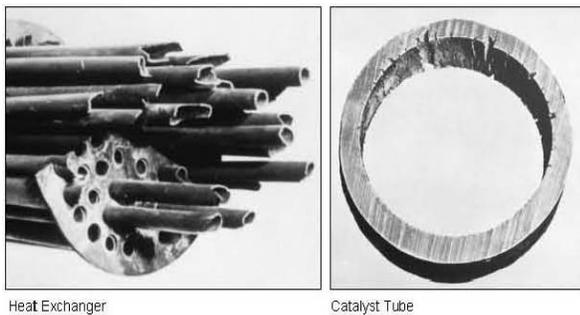
Fig. 1 shows an overview of a destroyed heat exchanger bundle and a catalyst-tube of a pilot plant.

Fig. 1: Failure by Hydrogen Attack in an Ammonia Pilot Plant in 1910

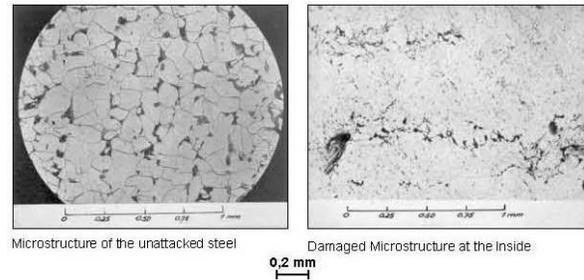
Bosch, who not only studied chemistry but also had excellent knowledge of metallurgy, conducted metallographic failure analysis and found out that the carbon steel exhibited decarburization combined with internal fissuring. As we know today these are the typical features of hydrogen attack. Figure 2 demonstrates these metallographic findings.

Fig. 2: Hydrogen Attack in a Catalyst Tube of an Ammonia Pilot Plant in 1910

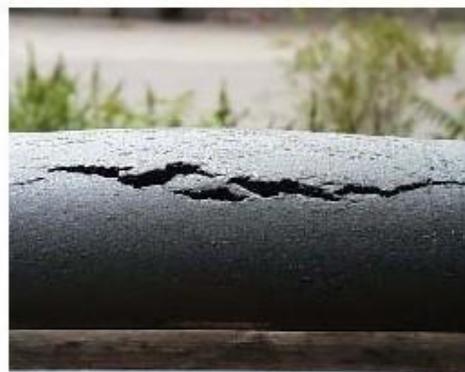
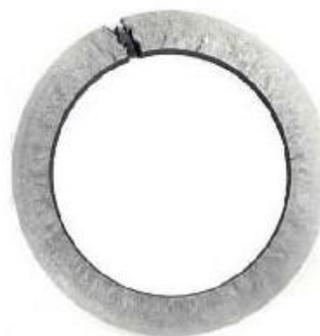
Fig. 4: Creep Damage in a Reformer Tube

In spite of periodic inspection during scheduled turnarounds ammonia plant No 3 experienced 4 tube failures after 11 years in service, which forced

shutdowns. All failed tubes were installed in the same area near the furnace wall and showed typical indications of creep damage.

longitudinal cracking

cross section

Based on the analysis of infrared pictures of the furnace the premature failure of the tubes could be correlated with a local higher temperature of 30 – 40 °C (50 – 70 °F) in combination with a higher average furnace temperature over the last three years.

One of the consequences was to replace 50 tubes, which were estimated to be creep damaged, another was to adjust the roof burners to get a more uniform temperature distribution. Additionally, the furnace temperature and the temperature distribution were extensively analysed by temperature measurements with an infrared camera every two months.

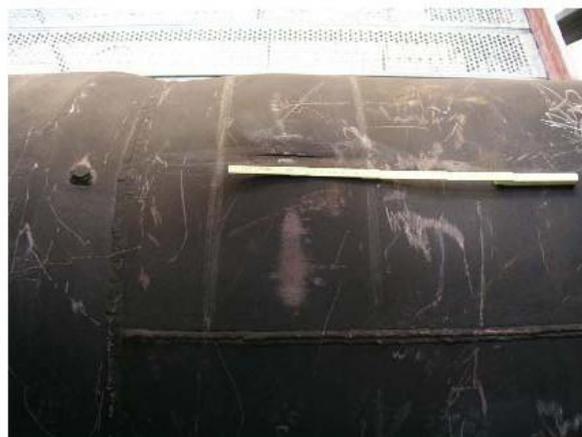
Figs. 5 to 8 show a failure of the transfer line from the secondary reformer to the boiler. In the course of the regular inspection with an infrared camera a hot spot was observed in the upper part of the line. Although the plant was directly shut down a bulge and a leak developed as demonstrated in fig. 5. After cutting away the steel shell the refractory seemed to be intact (fig. 6).

Fig. 5: Leakage and Bulging of the Transfer Line after a Short Term Overheating

The remedy in this case comprised several actions. One was to build up the refractory lining in a different and more stable way than it had been. Secondly the steel shell was changed from an unalloyed steel to a 0,5 Mo-steel with a higher high temperature strength which is believed to be beneficial as it will withstand the hot gas and the high pressure for a longer time if a similar incident occurs. Finally the inspection periods of the transfer lines and the secondary reformer with an infrared

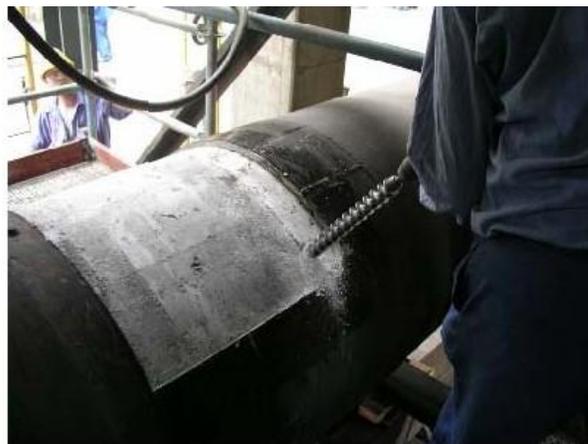
Fig. 6: Refractory after cutting away the Steel Shell

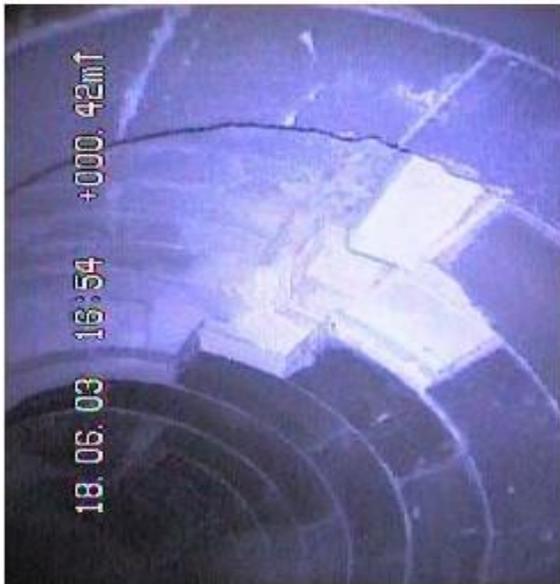
In the course of an internal visual inspection with an endoscope which was led through a hole drilled in the refractory it became very evident that the bricks were gone in the area where the hot spot occurred (fig. 7).

Fig. 7: Bricks Broken off the Refractory Lining in the Over Head Position of the Transfer Line

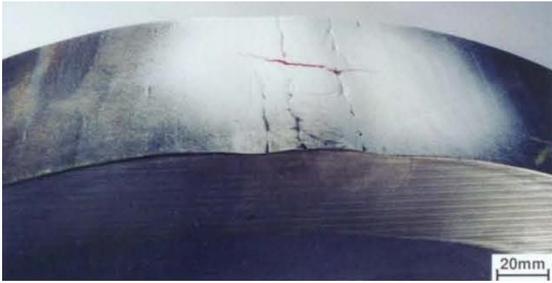
outlet header, extensive dye-penetrant testing was conducted which revealed cracking close to the pipe-to-tube connection weld in the pipe material and in the vicinity of the longitudinal weld. The crack in the pipe material close to the pipe-to-tube connection welds followed part of the circumference of the connection weld, then crossed over in the longitudinal direction to the next pipe-to-tube connection weld, where it again followed part of the connection weld etc. In the vicinity of the longitudinal weld, cracking was found in the longitudinal direction in the heat-affected zone and in the transverse direction crossing the weld. Figures 10 and 11 show the cracking in a segment, which was cut out of the header.

Fig. 10: Relaxation Cracking in an Alloy 800 H Outlet Header

Practically all austenitic and Ni-base materials usually applied at elevated temperatures are more or less susceptible to relaxation cracking, if they contain carbon in an amount considerably above the solubility. A remedy with respect to this kind of cracking is a final heat treatment, which in case of alloy 800 H should be in the range of 950 °C (1740 °F). At this temperature the carbide precipitations are coarser and therefore the difference in strength between the grain boundaries and the grain interior is reduced. In the course of the fabrication of a new header, a two stage heat treatment was performed. After cold bending a heat treatment at 950 °C (1740 °F) was performed followed by a heat treatment at 850 °C (1560 °F) after welding.

Another way to handle relaxation cracking problems is to select the austenitic steel 1.4910, X 3 CrNiMoN 17-13 which is low in carbon content and nitrogen alloyed. This has proven to be a good remedy as well in other cases where relaxation cracking took place.

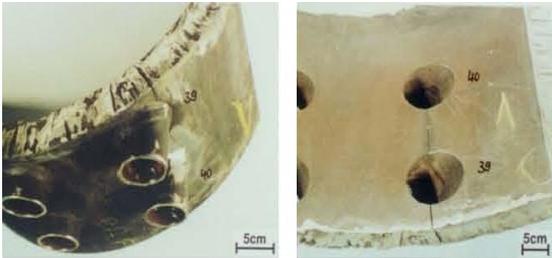
Fig. 11: Relaxation Cracking in an Alloy 800 H Outlet Header

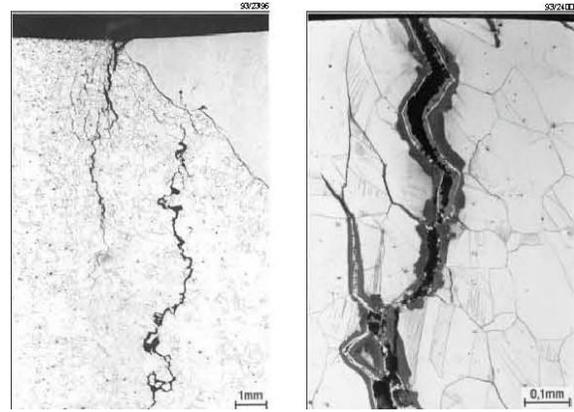
Metallographic examinations of cross-sections revealed intergranular cracking starting from the outside in all cases. At the borders of the cracks, oxide layers are present with a metallic filament rich in Nickel in the middle (see fig. 12).

Fig. 12: Relaxation Cracking in an Alloy 800 H Outlet Header

These are indications of relaxation cracking. Relaxation cracking in materials like alloy 800 H is caused by high residual stresses from fabrication (cold deformation, welding) or by cyclic deformation during service at temperatures in the range of 550 to 760 °C (1020 to 1400 °F) [3]. In this temperature range, the critical nucleation radius for carbide precipitation is very small. The fine carbides (mainly chromium carbides) are precipitated within the grains at dislocations and slip bands after short periods of time leading to a strengthening of the grains (see fig. 13).

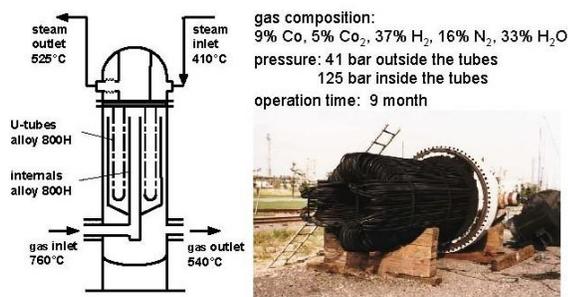
Fig. 15 shows the schematic drawing of the superheater with a U-tube bundle and the pulled U-tube bundle together with the service conditions. Due to a design temperature of 650 °C (1200 °F), the U-tube bundle and also the liner were initially made of alloy 800 H.

Fig. 15: Metal Dusting at a Superheater of the NH₃-Plant at BASF Antwerp

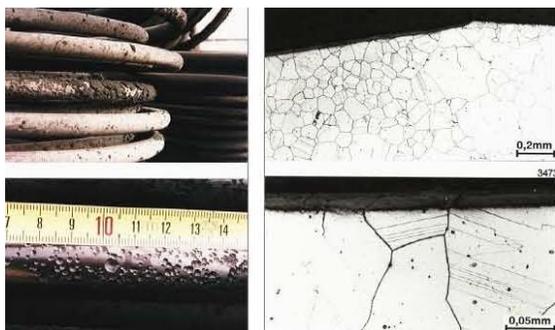
After about 9 month of service, heavy coking was observed on the U-tube bundle and liner. After removal of the coke, heavy pitting shaped metal dusting attack was observed. Fig. 16 shows an attacked part of the bundle in an overview, and metallographic sections of pits indicating the heavy carburization in the pitted area. In the unaffected area no carburization is observed. The 800 H liner was also attacked by metal dusting, while the alloy 600 weld of the liner was undamaged.

Fig. 16: Metal Dusting at a Superheater of the NH₃-Plant at BASF Antwerp

600-type was not attacked already gave an idea of the remedy. However since the first bundle several others using alloy 600, alloy 601 finally demonstrated that alloy 600 is obviously an appropriate material selection for this case. Alloy 601 was considerably worse and in another alloy 600 replacement bundle other failures occurred. One of the main problems when looking at many processes in the petrochemical industry is, that all of them are running under conditions where the gas phase has carbon activities much higher than 1. Although several research programs on metal dusting have been run, there is still a problem predicting the criticality of the gases conducting an economically and technically appropriate material selection. What has been elaborated in a research program at TNO [7] is a ranking of materials as shown in fig. 18, which is in a certain way reproducible. However the surface treatment is also important. Ground and sandblasted surfaces seem to be superior compared with other surface treatments.

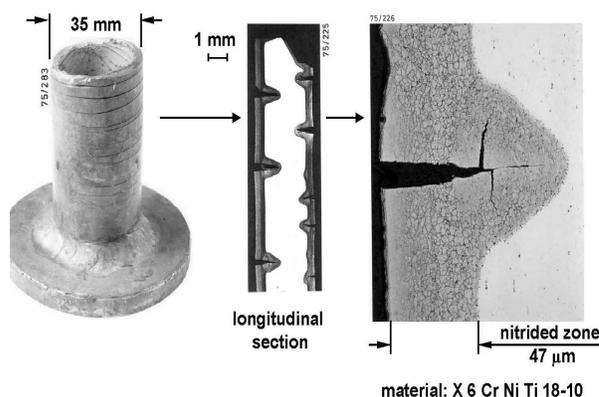
°C (970 °F). Fig. 19 shows a thermowell tube made out of the austenitic steel grade 321 (X 6 CrNiTi 18-10), which failed due to nitriding. Normally these tubes, which are pushed through the different catalyst layers, are changed on a regular time basis. This tube was missed to replace, so that the nitriding reached a critical amount. In the external dark area the nitriding is so heavy that practically all of the chromium contained in the material is consumed. Because of the residual stresses combined with the formation of such a zone, which is brittle in nature, an equidistant cracking takes place, which leads to locally deeper nitriding. Finally the remaining cross section was no longer sufficient and rupture occurred.

Fig. 19: Fracture of a Thermowell Tube due to Nitriding

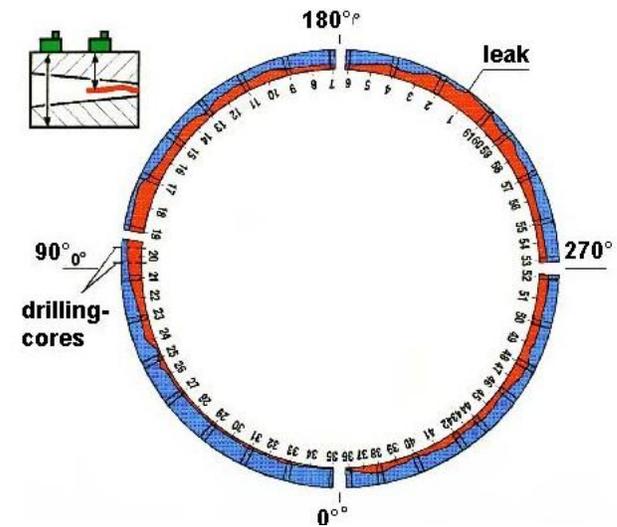
Fig. 23 indicates the depth of cracking attained over the circumference of the weld.

Fig. 23: Converter C 702 – Crack Path and Partition of Cracked Welded Seam

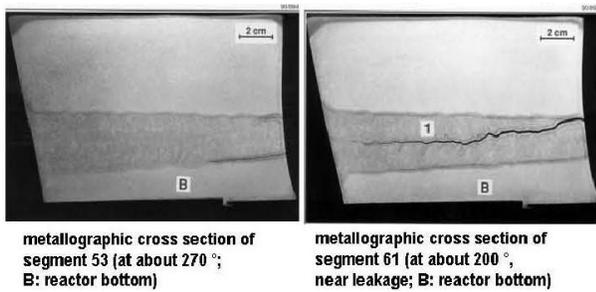
Metallographic cross sections of the weld revealed a very distinct appearance of the microstructure along the cracks (Fig. 24).

Fig. 24: Converter C 702 – Failed Closing Seam

Cracking was intergranular and the cracks were accompanied by a band indicative of decarburization [6]. Obviously cracking was assisted by hydrogen attack. The mechanism responsible for the damage is demonstrated in fig. 25.

The plant management later on decided to replace the reactor. Again a 2 ¼ Cr-1 Mo was selected. The wall thickness, however, was adjusted to comply with an ASME-design. Furthermore it was decided that a final heat treatment had to be conducted in a furnace. Still during the regular shut downs, the girth welds of the reactors are inspected with a highly sophisticated ultrasonic testing program. Up to now, no cracks have been detected in the new reactor.
