Failure Mechanisms and Material Degradations at High Temperatures in Ammonia Plants

Dr. Jürgen Korkhaus
BASF Aktiengesellschaft

Dr. Rainer Feser
BASF Aktiengesellschaft

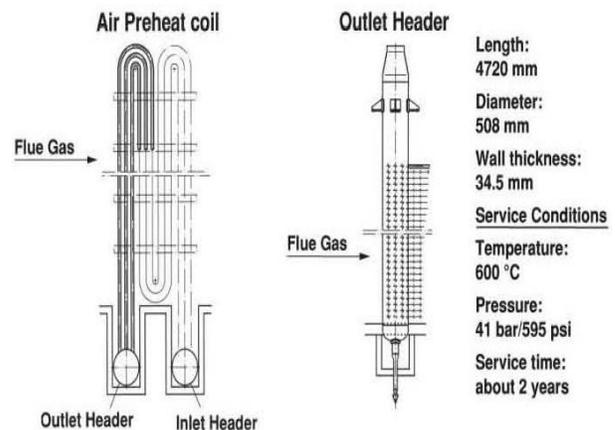
Fig. 9: Air Preheat Coil and Outlet Header

In the modern steam reforming ammonia process the preheating of compressed air to high temperatures makes the selection of austenitic materials necessary. Design temperatures of more than 600 °C (1110 °F) are common. This was the case in BASF's Antwerp ammonia plant [2]. The air preheater coil and the headers are therefore made out of alloy 800 H. Fig. 9 shows the air preheater coil and the headers in a sketch.

In the outlet header cracking was experienced after 2 years of service. The outlet header (see fig.9 on the right side) has a diameter of 508 mm (20 in), a length of 4720 mm (186 in) and a wall thickness of 34,5 mm (1,36 in). The operating temperature is about 600 °C (1110 °F) (design temperature 630 °C (1165 °F)). The header was manufactured out of solution annealed alloy 800 H plate material, which was sequentially cold bent into a cylindrical shape and then longitudinally welded with an alloy 600 Ni-base filler.

outlet header, extensive dye-penetrant testing was conducted which revealed cracking close to the pipe-to-tube connection weld in the pipe material and in the vicinity of the longitudinal weld. The crack in the pipe material close to the pipe-to-tube connection welds followed part of the circumference of the connection weld, then crossed over in the longitudinal direction to the next pipe-to-tube connection weld, where it again followed part of the connection weld etc. In the vicinity of the longitudinal weld, cracking was found in the longitudinal direction in the heat-affected zone and in the transverse direction crossing the weld. Figures 10 and 11 show the cracking in a segment, which was cut out of the header.

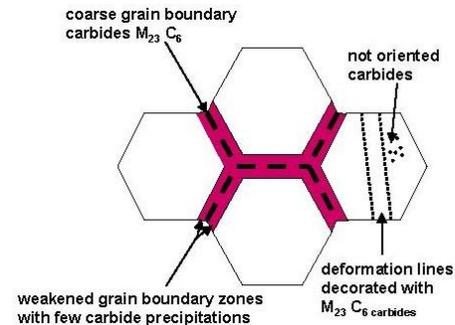
Fig. 13: Microstructural Constitution of Alloy 800 H after Service at about 550 – 760 °C

These are indications of relaxation cracking. Relaxation cracking in materials like alloy 800 H is caused by high residual stresses from fabrication (cold deformation, welding) or by cyclic deformation during service at temperatures in the range of 550 to 760 °C (1020 to 1400 °F) [3]. In this temperature range, the critical nucleation radius for carbide precipitation is very small. The fine carbides (mainly chromium carbides) are precipitated within the grains at dislocations and slip bands after short periods of time leading to a strengthening of the grains (see fig. 13).

At the grain boundaries, coarse chromium carbides are present, leading to chromium depletion in the vicinity. Consequently precipitation free zones having low strength occur beside the grain

boundaries. Because of the relative difference in strength between the grains and the grain boundaries, deformation under relaxation conditions will take place at the soft grain boundaries leading to crack formation at relatively low overall deformations. A similar mechanism was proposed to explain the stress relief cracking in microalloyed steels.

Practically all austenitic and Ni-base materials usually applied at elevated temperatures are more or less susceptible to relaxation cracking, if they contain carbon in an amount considerably above the solubility. A remedy with respect to this kind of cracking is a final heat treatment, which in case of alloy 800 H should be in the range of 950 °C (1740 °F). At this temperature the carbide precipitations are coarser and therefore the difference in strength between the grain boundaries and the grain interior is reduced. In the course of the fabrication of a new header, a two stage heat treatment was performed. After cold bending a heat treatment at 950 °C (1740 °F) was performed followed by a heat treatment at 850 °C (1560 °F) after welding.

Another way to handle relaxation cracking problems is to select the austenitic steel 1.4910, X 3 CrNiMoN 17-13 which is low in carbon content and nitrogen alloyed. This has proven to be a good remedy as well in other cases where relaxation cracking took place.

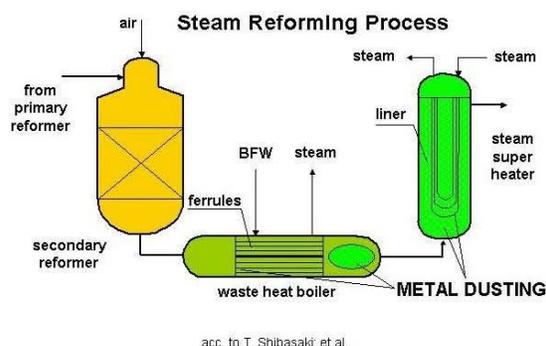
Fig. 14: Location of Metal Dusting Found in the Outlet Portion of Waste Heat Boilers

Fig. 14 gives a schematic drawing of the waste heat recovery units downstream of the secondary reformer. At first there is a boiler, which in some modern plants is followed by one or two superheaters. In the boiler the hot gas from the secondary reformer is led through the tubes, the boiler feed water is on the outside. The superheaters in many cases consist of U-tube bundles.

In both apparatus the gas consisting of CO, CO₂, H₂ and N is cooled down under non-equilibrium conditions, where the carbon activity considerably exceeds the value of 1. The carbon activity is determined by the partial pressure of carbon in the gas phase. The vapour pressure of carbon above a solid carbon body represents per definition a carbon activity of 1. Carbon activities in excess of 1 are a prerequisite for metal dusting. In the areas indicated, metal dusting has been experienced in boilers and superheaters [4]. In the ammonia plant of BASF in Antwerp, a serious case of metal dust-

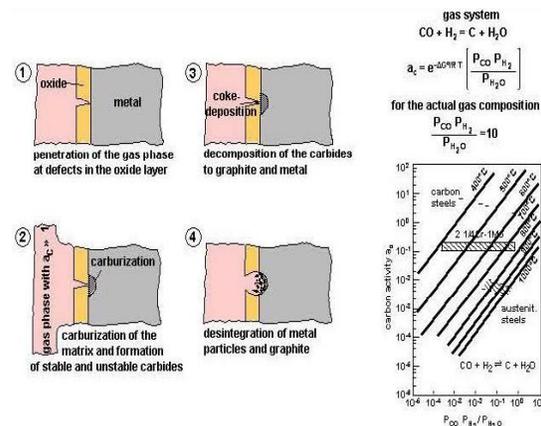
Fig. 17: Failure Mechanism by Metal Dusting

In Fig. 17 the failure mechanism by metal dusting is shown in principle and a simplified quantification to estimate the carbon activity is demonstrated on the right side. Metal dusting is an attack, which requires a carbon activity in excess of 1. For austenitic steels and Ni-base alloys, it has been experienced that temperatures of about 600 to 650 °C (1110 to 1200 °F) are the most critical ones in syngas atmospheres.

The surface of the material is, for the most part, protected from gas phase carburization by an oxide film. At defects like cracks etc., which may arise in the oxide layer, the gas phase having a carbon activity above 1 comes into contact with the bare metal surface directly leading to carburization and the formation of stable and unstable carbides. Since the bare metal surface also acts as an active site for coke deposition from the gas phase, coke depositions will form which lead to a dramatic change of the thermodynamic reference system. By this, carbides that are only stable in equilibrium with the gas phase will decay into graphite and metal. Due to the higher specific volume of the graphite, disintegration of the material into metal particles and graphite takes place. In the specific case of the superheater bundle, the tubes made of alloy 800 H lost about 0,9 mm (35,4 mils) within 9 month, which is about 1/3 of the total wall thickness. This indicates the high rate of the attack. The observation that the weld metal made of an alloy

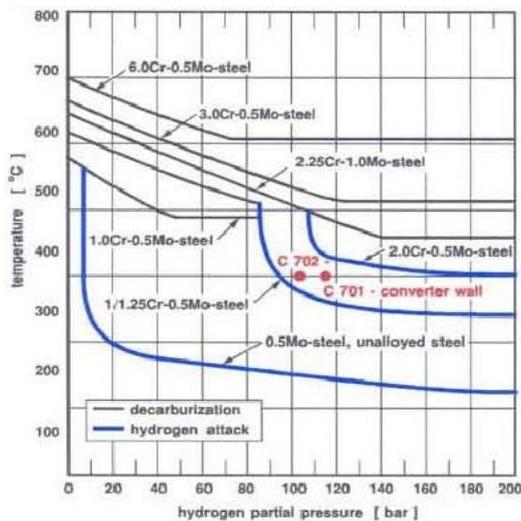
Fig. 21: Operating Limits of Steels in Hydrogen Service to Avoid Decarburization and Fissuring

Fig. 21 demonstrates where the operating conditions of the two reactors are located with respect to the temperature and the hydrogen partial pressure in the Nelson diagram. After eight years of operation a leak was observed within a 175 mm (6,9 inch) thick girth weld – the closing seam - of the second reactor, the reactor with the higher ammonia concentration. Extensive ultrasonic testing and metallographic examinations revealed a considerable amount of cracking in the whole circumference of the weld [5].

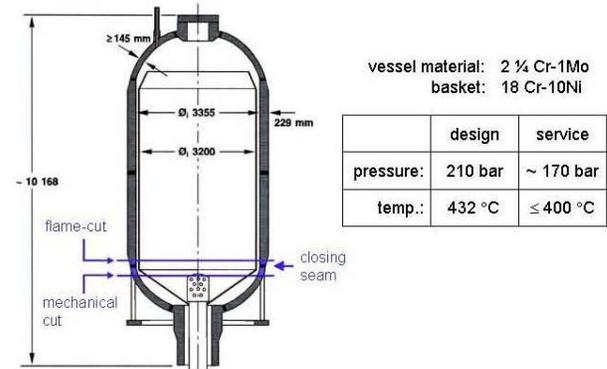
Fig. 22: Converter C 702

Fig. 22 shows a sketch of converter C 702 and the position of the closing seam, which was cut out in the course of the repair work.

The plant management later on decided to replace the reactor. Again a 2 ¼ Cr-1 Mo was selected. The wall thickness, however, was adjusted to comply with an ASME-design. Furthermore it was decided that a final heat treatment had to be conducted in a furnace. Still during the regular shut downs, the girth welds of the reactors are inspected with a highly sophisticated ultrasonic testing program. Up to now, no cracks have been detected in the new reactor.

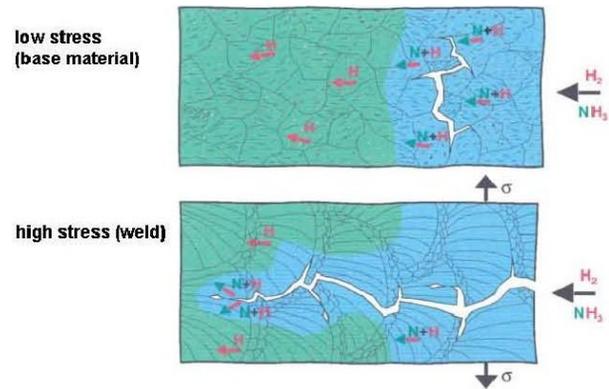
Fig. 25: Damage by Synthesis Gas

Cracking was intergranular and the cracks were accompanied by a band indicative of decarburization [6]. Obviously cracking was assisted by hydrogen attack. The mechanism responsible for the damage is demonstrated in fig. 25.

The initial step of cracking is nitriding by ammonia. Since the chromium carbides in the steel, which protect it from hydrogen attack, are less stable than chromium nitrides, chromium carbonylides are formed and a certain amount of carbon is released. This carbon methanates in combination with the hydrogen dissolved in the material. In case of low mechanical stresses, a nitrided zone is formed in which cracking by hydrogen attack occurs parallel to the surface as shown in the upper part of fig. 25. The decisive point for the cracking perpendicular to the surface was that, in the closing seam, high residual stresses were present after fabrication, because this seam was locally heat treated. Under the action of these high stresses, cracking by hydrogen attack no longer happens parallel to the surface but perpendicular to it, as indicated in the lower section in fig. 25.

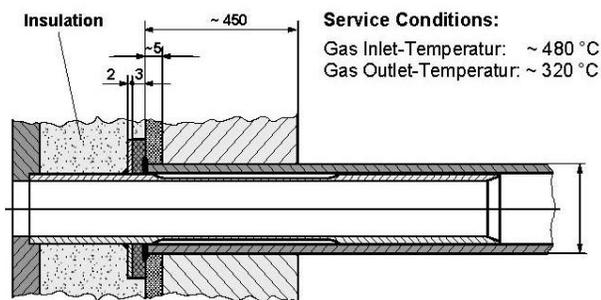
Fig. 26: Inlet-Part of a Process Cooler of an Ammonia Plant

As indicated in the process scheme in fig. 20, heat recovery is conducted in the conversion by pre-heating the synthesis gas (W 721, W 723) and by steam production (W 722). As the vessels are charged with ammonia and hydrogen containing gas at high temperatures, there is always the potential of nitriding, hydrogen attack and embrittlement. Due to the high pressures involved, conventional low alloyed Cr-Mo-steels are applied, having excellent strength at the service temperatures. In order to handle the problem of nitriding and hydrogen attack and embrittlement, intelligent designs have been developed which make it possible to run heat exchangers fabricated from these materials under such critical conditions in long term service. Fig. 26 demonstrates an example of such a design for a boiler directly heated with hot, high ammonia concentration gas.

For pressure and temperature reasons, the tube sheet of the gas cooler has a thickness of more than 400 mm (15,75 inch). The hot gas is led through the tubes. To protect the tube sheet from direct contact with the hot gas having a temperature of more than 400 °C (770 °F) there is high temperature insulation on the tube sheet. The hot gas is led through alloy 600 H type ferrules in this area.
